RICS **HomeBuyer Report**

SAMPLE

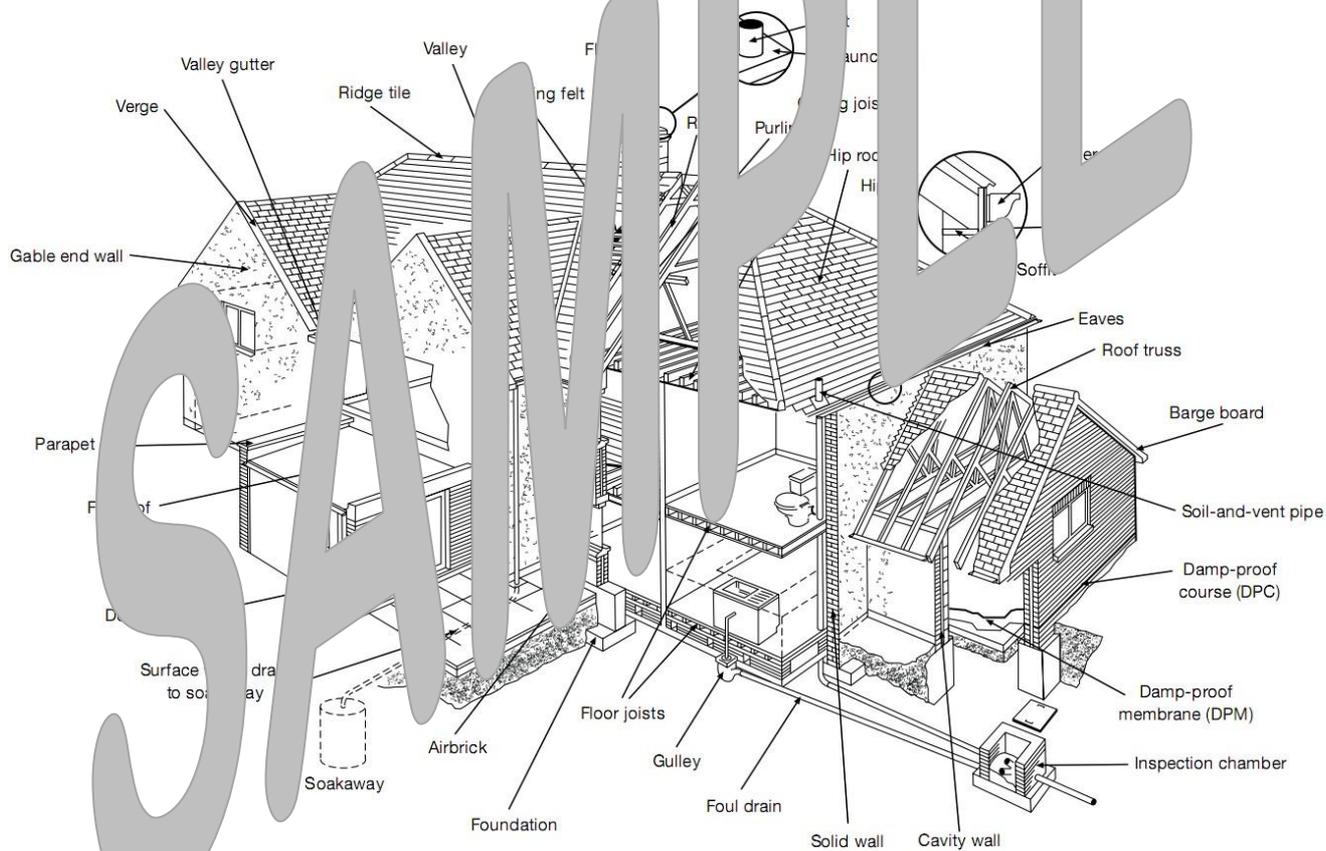
Typical house diagram

This diagram illustrates where you may find some of the building elements referred to in the report.
